Bringing Sash Windows Back to Life

his project represented a fascinating challenge as The Old House dates back to Elizabethan times –as evidenced by the design of the front elevation groundfloor windows – but with later additions and amendments, resulting in a range of window styles. Unfortunately, many years of internal redecoration had left some sashes effectively sealed and poor maintenance had led to varying degrees of decay in the external timbers.

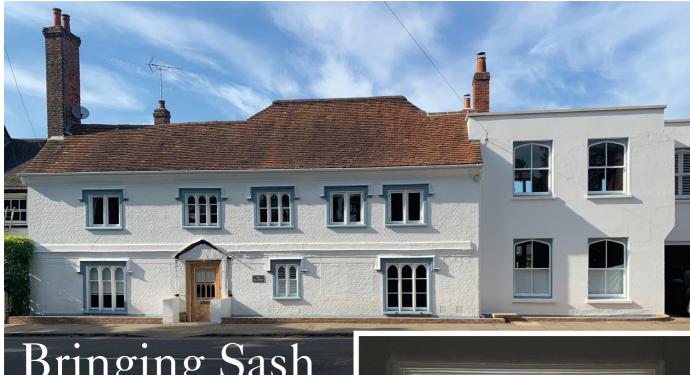
Front elevation with works completed

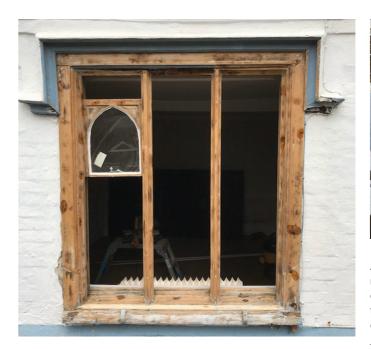
Right: Solution for operating the internal sash shutters

When it came to one of the Georgian eightover-eight units, there was evidence of vertical, internal shutters that had been sealed up. Once the hinged cover piece had been freed, the two shutters were able to be refurbished. The pulleys had been blocked with paint and some form of filler and needed to be replaced before commissioning. The original pull rings had been removed and so a pair of Heritage Brass recessed pulls was used.
